Swim Care Pool Services Inc.
4203 Genesee Ave # 103-446
San Diego, Ca 92117
Cali Contractors License # 1003497

Pool Leak Report

This report is for the residence of located in sunny La Jolla, Ca 92037. This report includes our findings from the pool, spa and auto fill networks hydraulic analysis of water distribution. For This test we use a hybrid approach of leak detection tools including: Electronic listening devices, Dye, Pressure testing kits & Pool light niche leak detectors. The findings should hopefully help in water conservation.

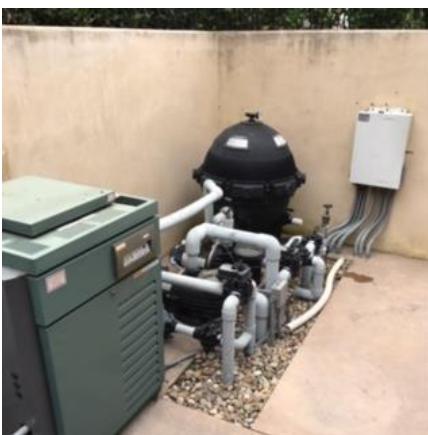
Pool Picture 02/10/17 1:27 PM.jpeg

Pool Structure Good no visual cracks
